Home Inspection Report

40 Morse Street
February 25th, 2019

Prepared by
APG Home Inspections
Adrian Guertin, PMP, CMI, CCHI
www.apghomeinspections.ca

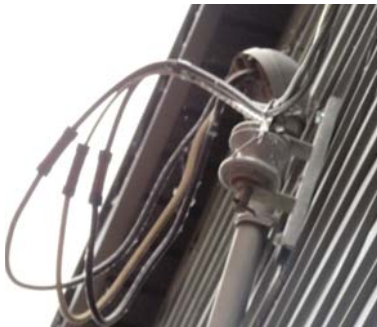
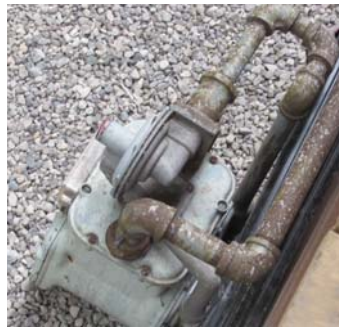
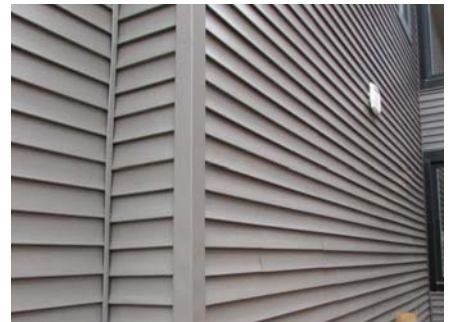
- 1- Overhead Service - Secure
- 2- Gas Line - 1" Feed
- 3- Siding in Good Condition

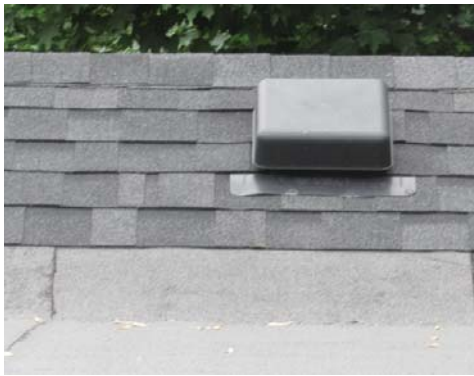
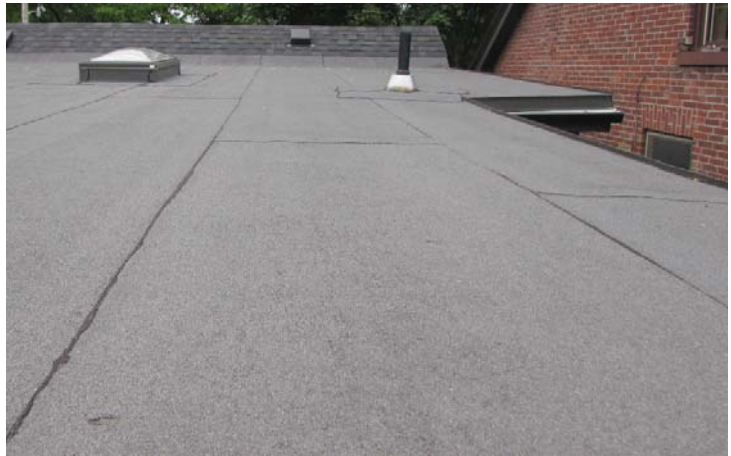
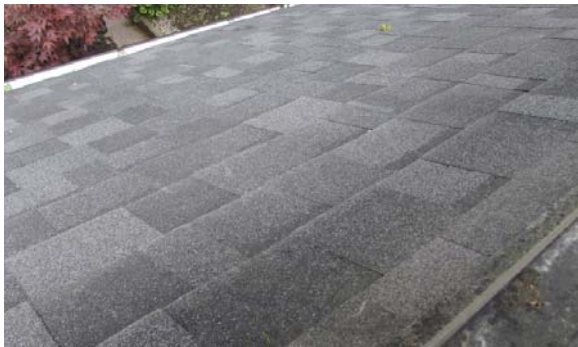
Newer Torched Membrane and Architectural Shingles
Good Overall Condition

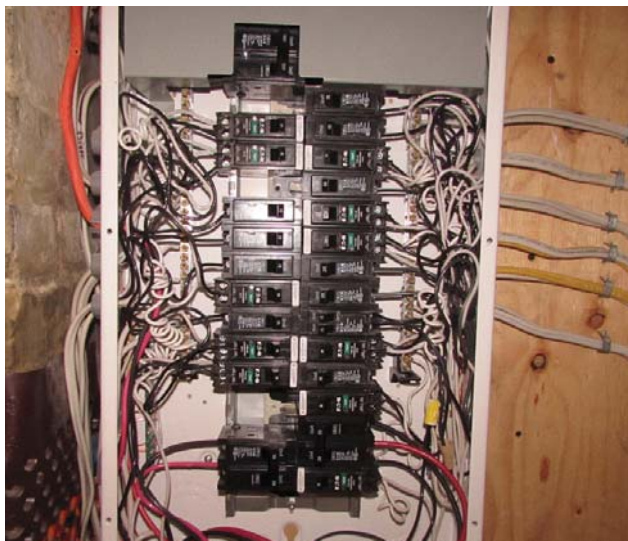
Electrical Panel Branch Wiring

100 Amp Service
Copper Wiring
Good Overall Condition

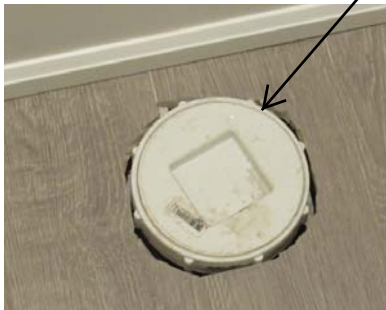
Backwater Valve -
Sewer Flood
Prevention

- 1- Access to Backwater Valve
- 2- Interior Weeping System
- 3- Storm Water Sump Pump with Check Valve

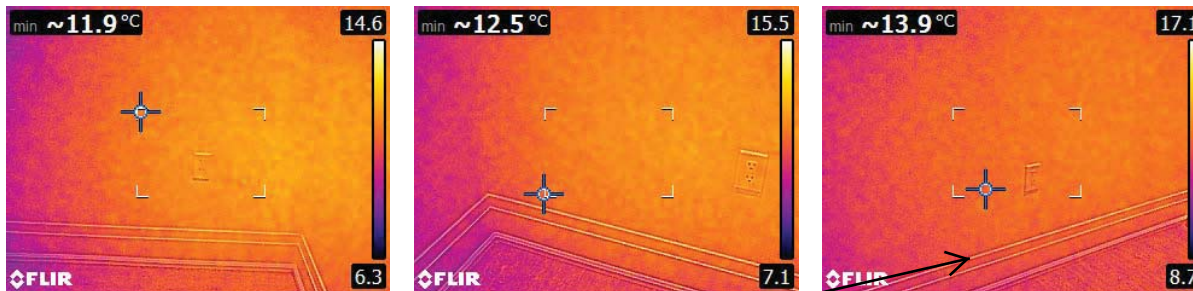
Basement Dry - No Evidence of Water Penetration

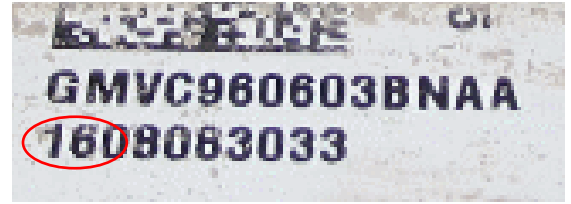
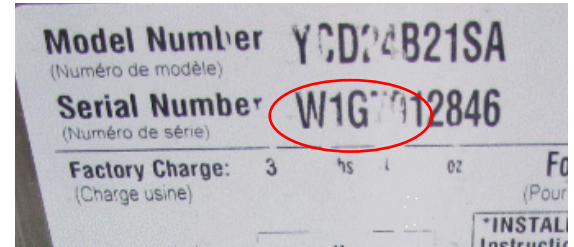
Newer Furnace and AC
 Appear in Very Good Condition
 Service Units Annually - Change Filter Every 3-4 Months
